# CLUTCHTECH

## TSB-264 Slow Pedal Return

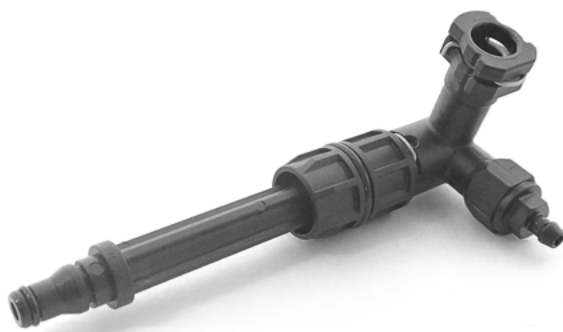
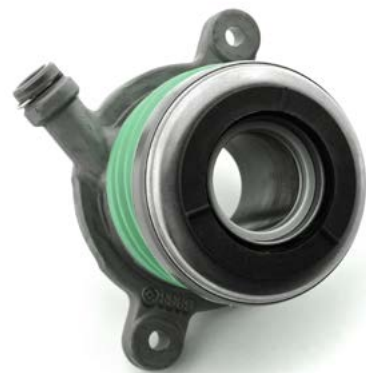
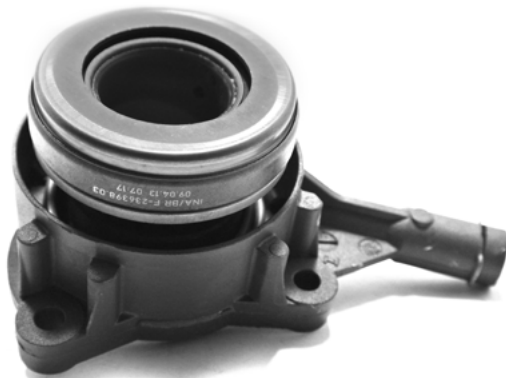
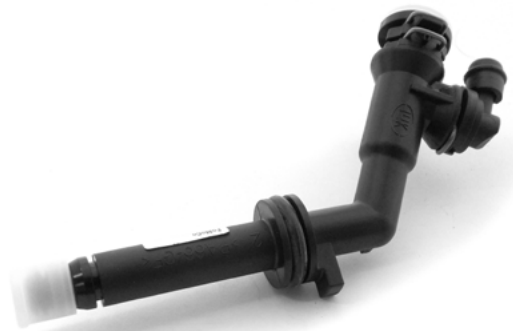
If the clutch pedal on this vehicle is slow to return or the Concentric Slave Cylinder (CSC) has failed and leaked, the connection and breather assembly pipe may need replacing.

The pipe assembly connects to the inlet of the CSC and has internal seals which can fail. When these seals fail, they can obstruct the fluid flow resulting in over stroking of the CSC or restricting the fluid movement.

For more information or replacement pipe connections please contact your nearest ClutchPro or Xtreme Outback distributor.
