TSB-257 Mazda 3 Clutch Fork

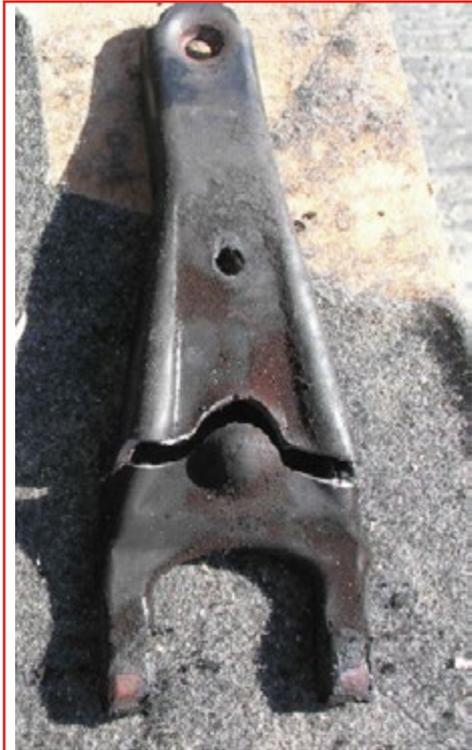
Clutch forks can fracture after excessive wear. It is important to check all points of contact when inspecting them.

In some Mazda 3 models, the original clutch fork is prone to failure. Therefore, it is highly recommended to inspect all of the components and check for any signs of wear or fatigue/ damage prior to fitting a clutch. If there are signs of wear, these components should be replaced to prevent an issue from occurring in the future.

Australian Clutch Services offer a replacement kit – ATFMZ01 including clutch fork, pivot ball and release bearing. The clutch fork and bearing are of a different design to OE and are significantly stronger.

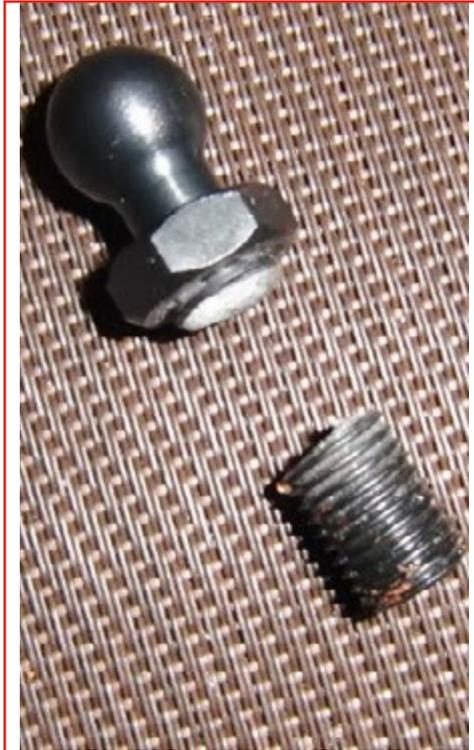
Pivot Balls can wear down in height, or even completely shear like in the above photo. Check for any witness marks of wear
