CLUTCHTECH

TSB-301 Release Mechanism Wear

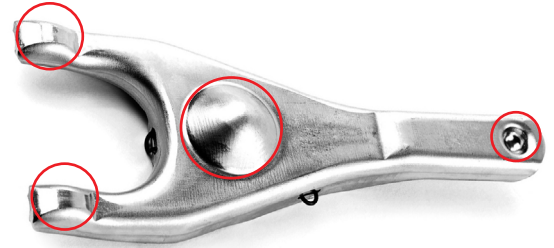
Remove and inspect the clutch fork. Check over the entire fork for wear/cracks/damage with extra focus on the constant contact areas (pivot ball, slave cylinder and thrust bearing contact points). It may require cleaning to be properly inspected. If there is any damage or significant wear present, it's highly recommended to replace the fork.

Remove and inspect the pivot ball. The ball should have an even, round profile. If it appears "squashed" or is cracked, it should be disposed of and replaced with a new one. It's good practice to replace the fork and ball together due to the labour intensive process of removing the transmission.

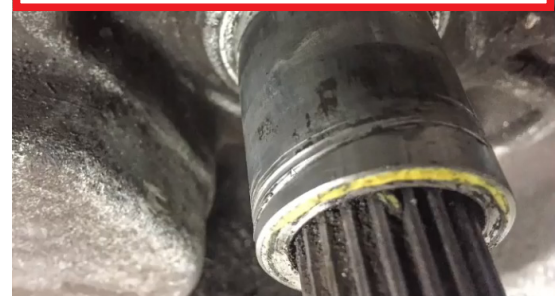
Inspect the snout of the transmission where the bearing slides. If there are deep gouges, burrs or any other damage, it is imperative that this gets rectified before the transmission is re-installed. If the damage is enough to effect the operation of the bearing, a new transmission may be required as the snout is part of the housing on these transmissions and is not replaceable.

Example of a Damaged Transmission Snout

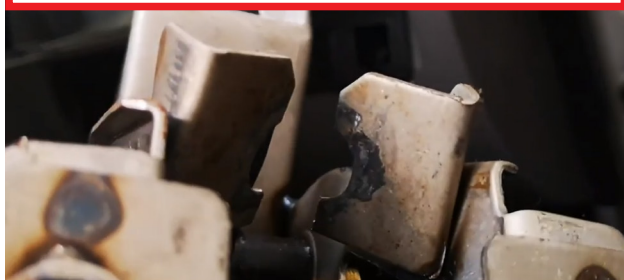
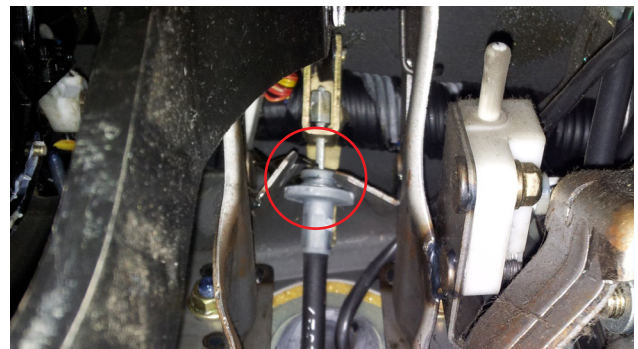
The pedal box and pedal arms should also be inspected as they are often prone to cracking/breaking but regularly over-looked when clutch issues arise. Carefully inspect the pedal box, surrounding fire-wall, pedal arms and pedal pivot points for any sign of damage or excessive movement. Any excess deflection in the pedal box will affect the operation of the clutch.

Broken Clutch Cable Mount on Pedal Box
