CLUTCHTECH

TSB-229 VF Over-centre Spring Removal

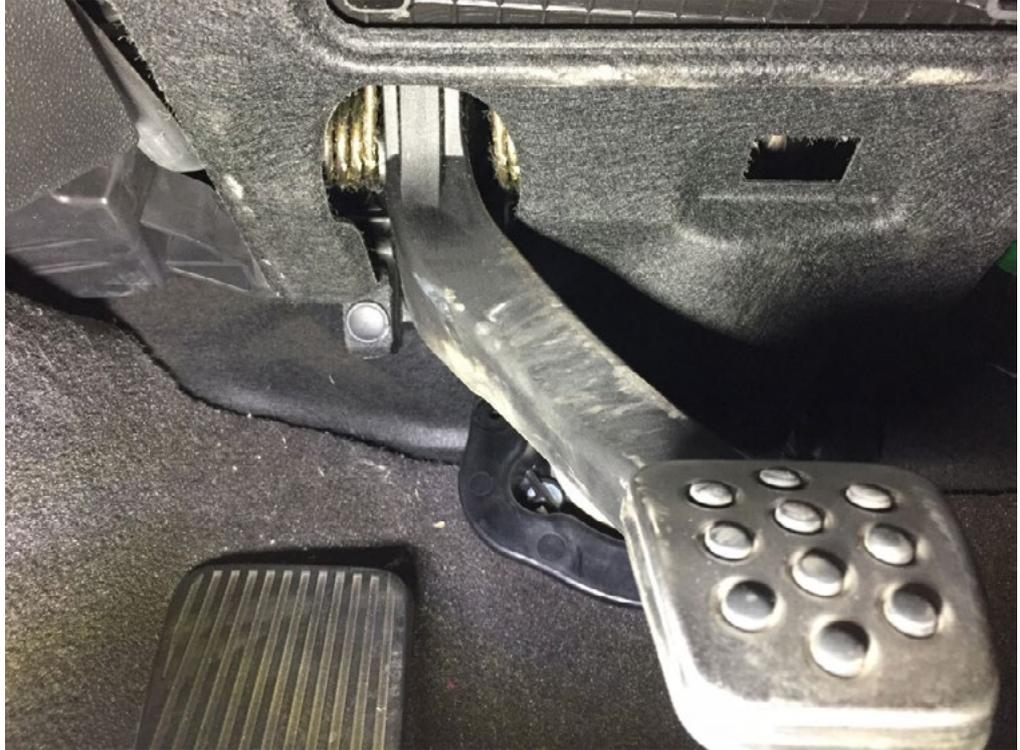
VF Commodores use an over-centre spring to decrease the pedal effort required to operate the clutch pedal. If a driver finds the operation effort inconsistent or the pedal sticking to the floor during gear changes, the spring can easily be removed to improve the pedal feel and prevent the pedal sticking to the floor.

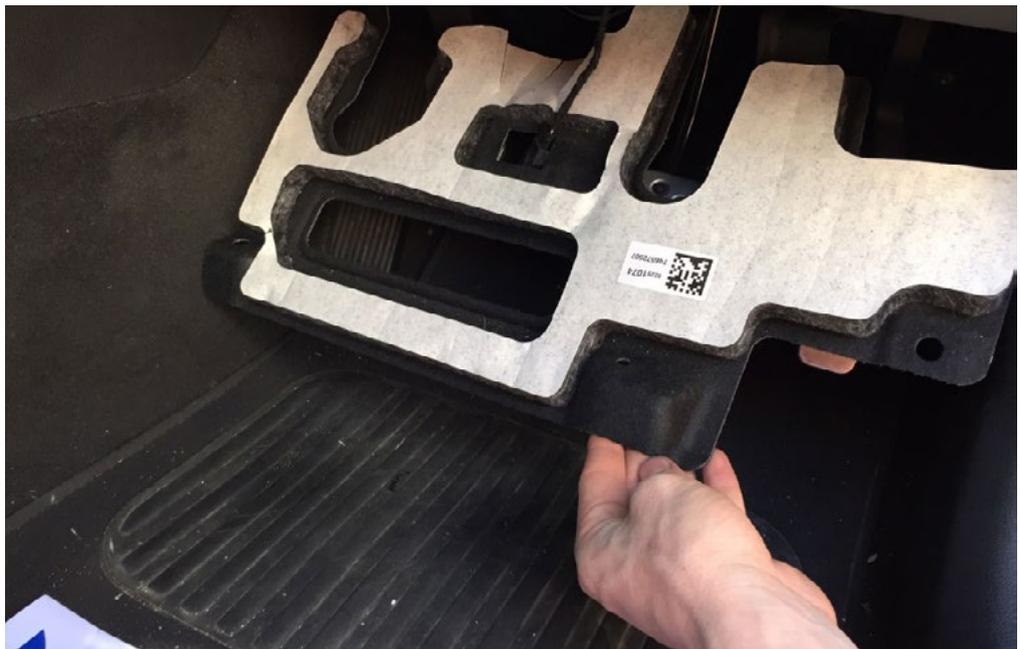
Remove the panel above the pedals to allow access to the spring.

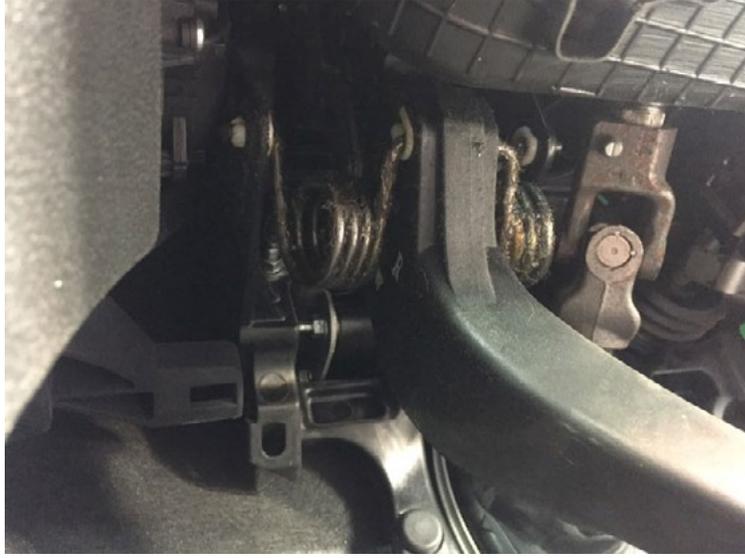
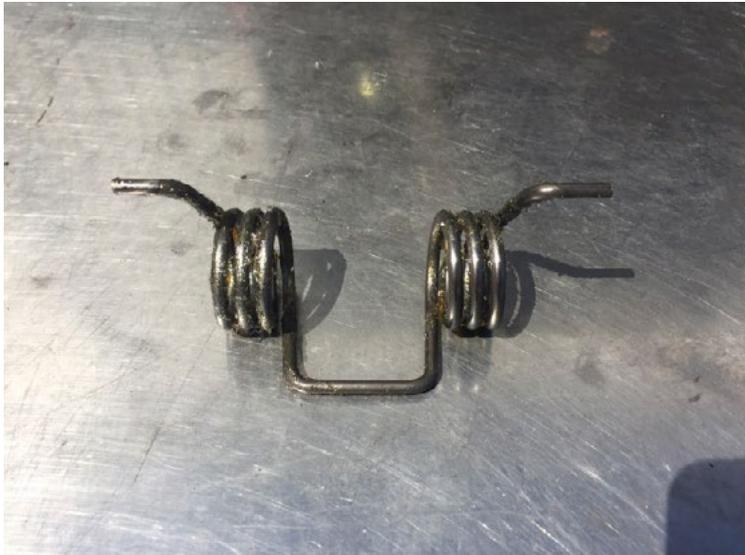
A flat blade screw driver can be used to pry out the spring.
BE VERY CAREFUL NOT TO DAMAGE THE CLUTCH POSITION SWITCH ABOVE THE SPRING!

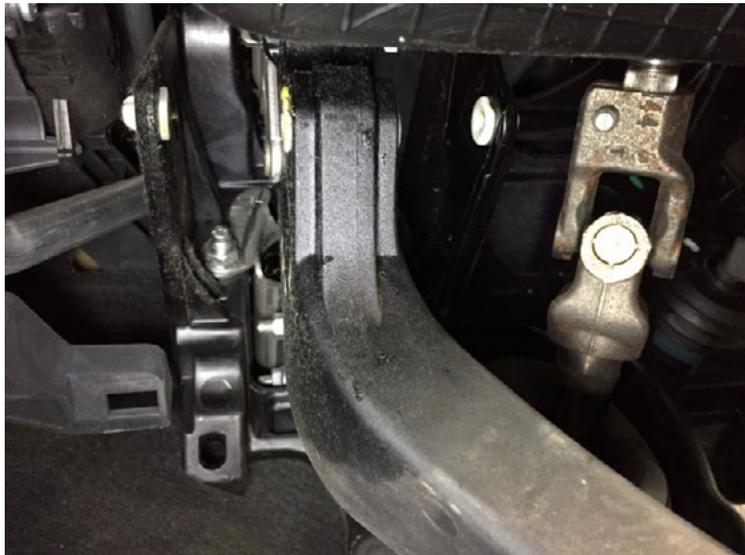
Spring removed from pedal assembly.
