# CLUTCHTECH

## TSB - M101

### Mitsubishi/Hyundai

This is an important notice which relates to Clutch Pivot Ball and Release Fork Wear.

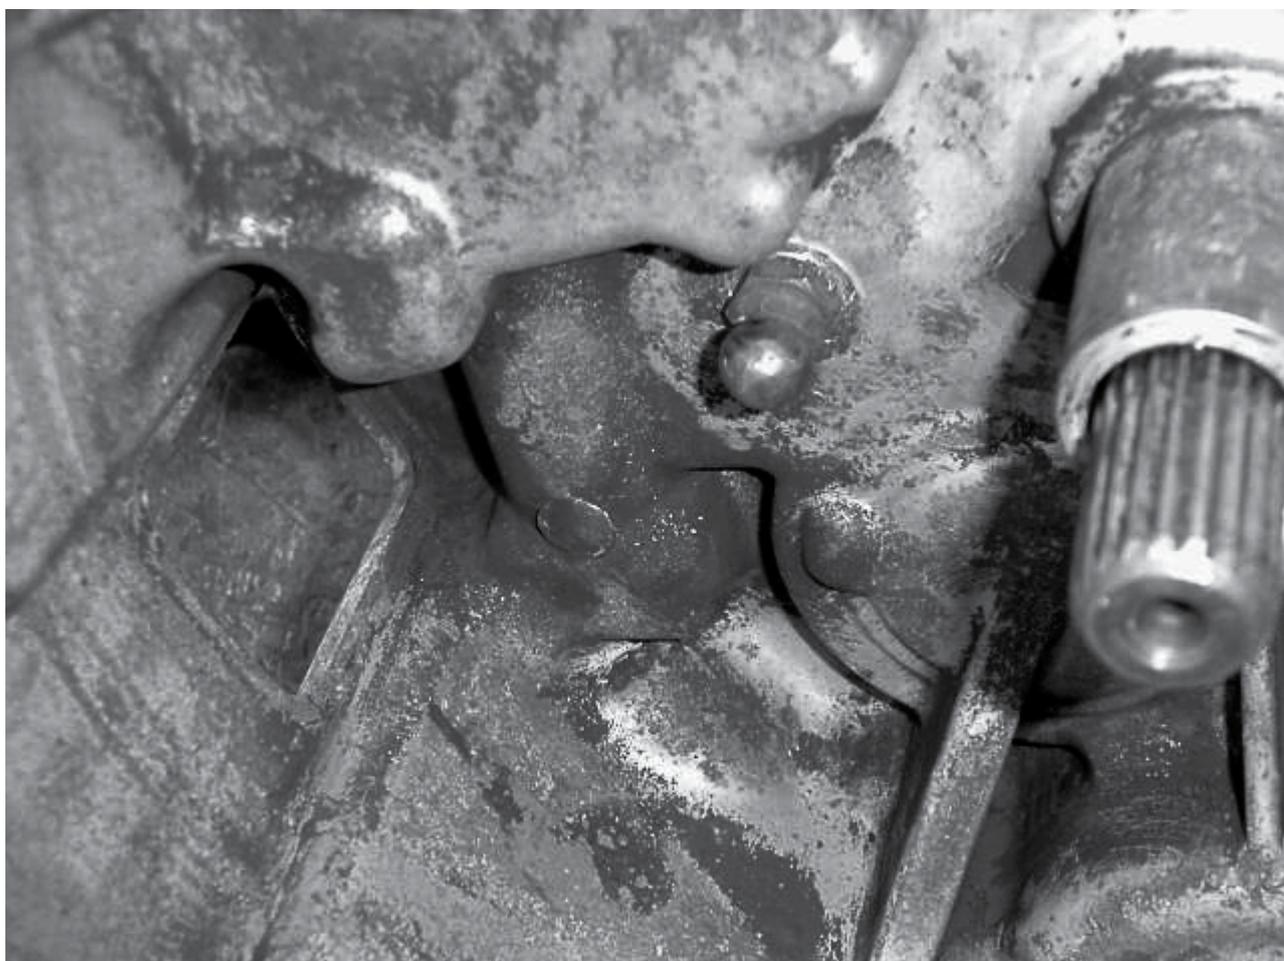
1. The clutch fork and pivot ball in this vehicle are prone to wear. Before fitting a new clutch, inspect the clutch fork, pivot ball and pivot ball seat for wear. If any wear is evident, the clutch fork and pivot ball must be replaced. Some kits are supplied with a pivot ball spacer shim. If your kit has one, you may use this under the pivot ball instead of replacing the 2 components providing they aren't damaged beyond use. Do not use a shim if the kit was not supplied with one.

2. Clean bell housing and all other gearbox components. After removal of gearbox, clean all components. Check gearbox bearing nose cone for wear. If worn, it must be replaced to avoid pedal graunch and notchy feel when new clutch is installed.
